CARNEGIE-MELLON UNIVERSITY  
MELLON INSTITUTE

INVESTIGATION OF STRESS CORROSION CRACKING OF TITANIUM ALLOYS

Semi-Annual Progress Report No. 4  
for the Period  
December 1, 1967 through May 31, 1968

E. G. Haney and W. R. Wearmouth

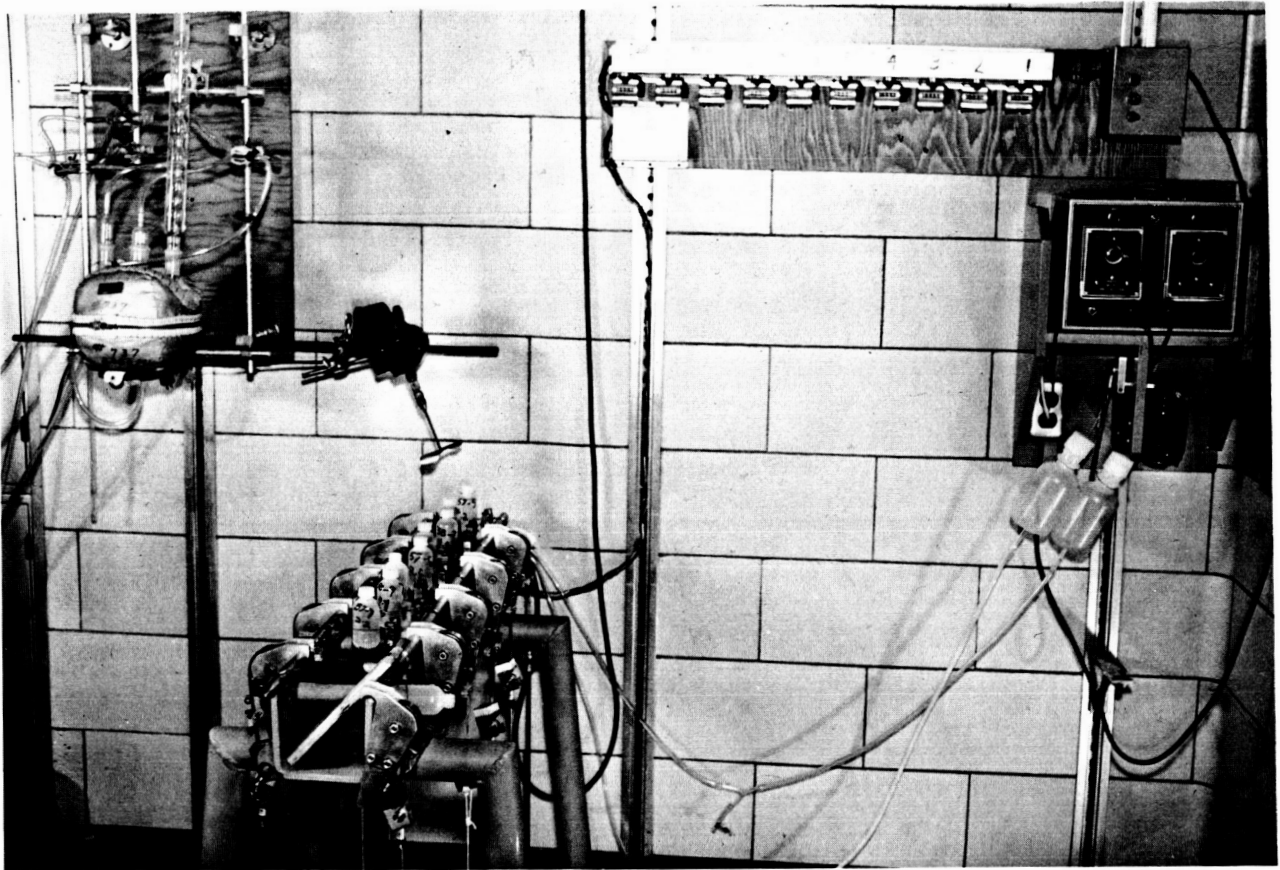
Figure 1--Apparatus for Stress Corrosion Testing of Foil at Constant Stress and its Auxiliary Equipment.

around the specimen in a polyethylene bottle. Figure 1 presents an overall view of the apparatus with the auxiliary equipment. To the right on the wall are 10 counters which record the times to failure of the individual specimens. The counters are activated by microswitches seen at close range in Figure 2. Also visible in Figure 2 are one of the broken specimens, about 4" long, after the polyethylene bottle has been removed, and a loaded specimen threaded through a polyethylene bottle containing the test solution. The specimens are clamped to straps on each side and the tension applied over a ball bearing on one side with a deadweight. The apparatus is also capable of testing partially immersed specimens, as shown in Figures 1 and 2, by loading the specimen in a vertical rather than horizontal position. Nearly all of the specimens investigated in the present work were totally immersed, however, and were loaded to 85% of Y.S. unless otherwise noted.

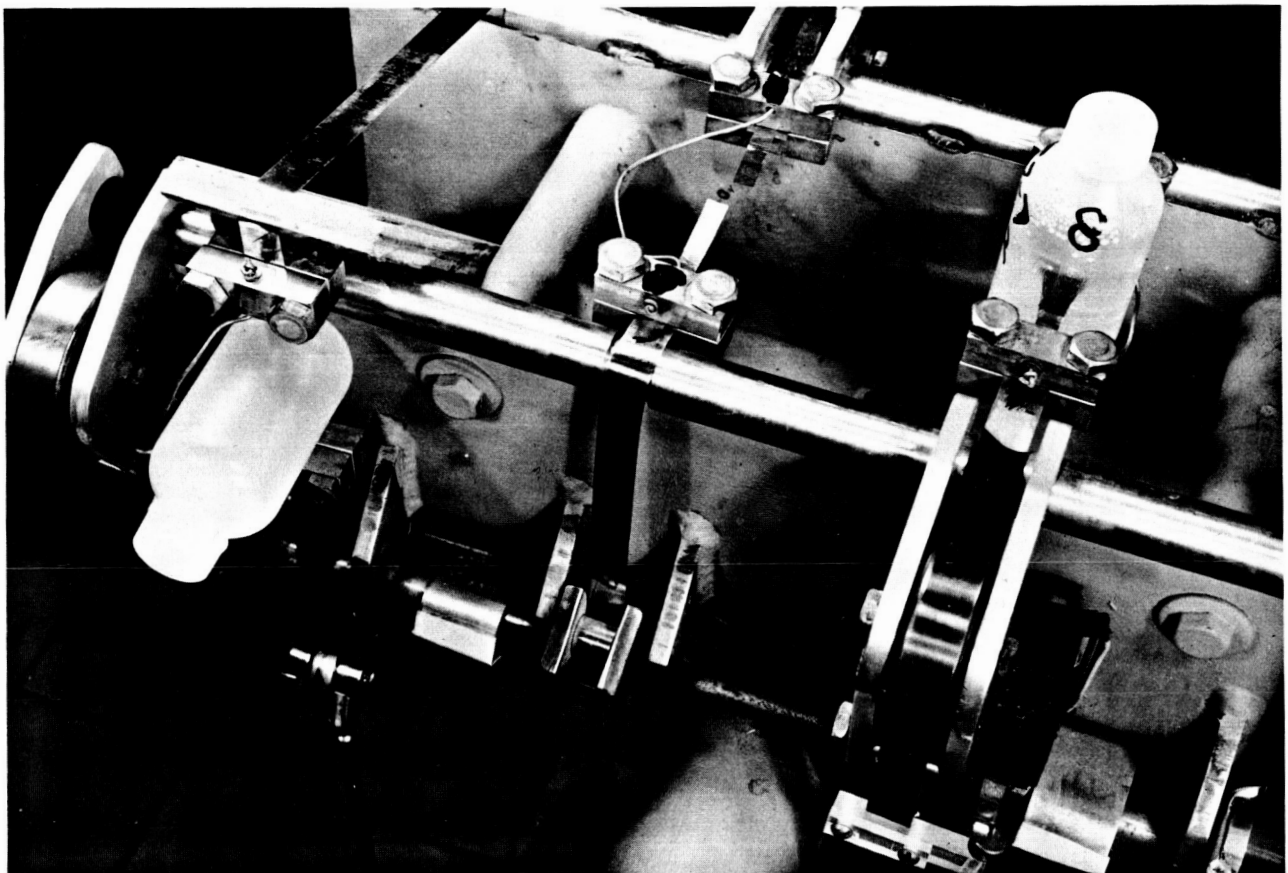
Figure 2--A closer view of stress corrosion testing apparatus showing partial immersion set-up (left), a cracked specimen with bottle removed (center), and a stagnant immersion test in progress (right).

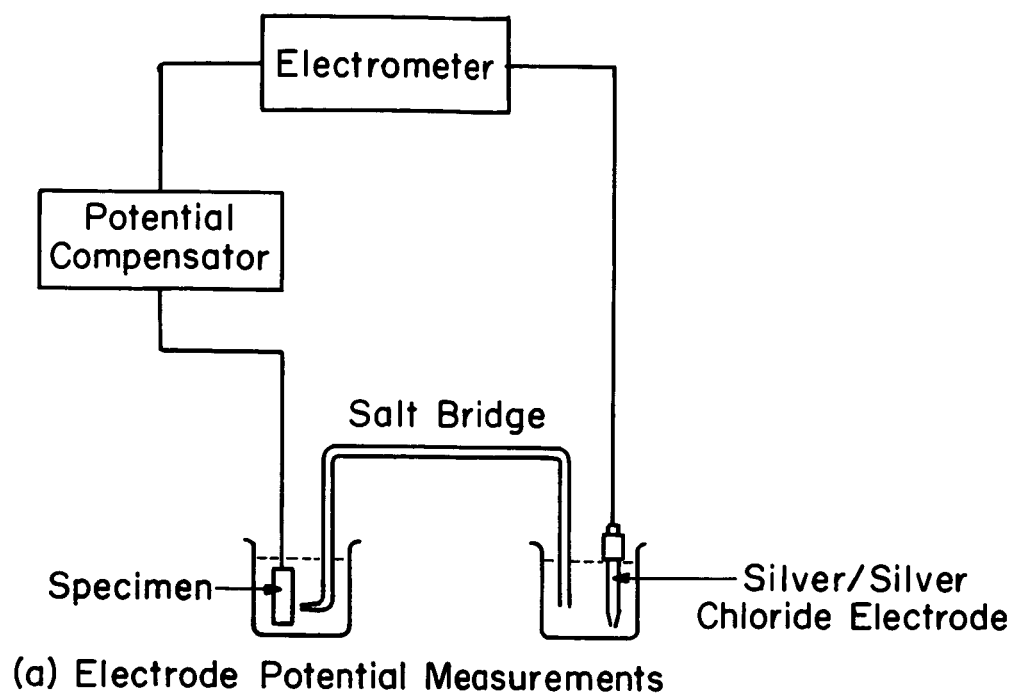
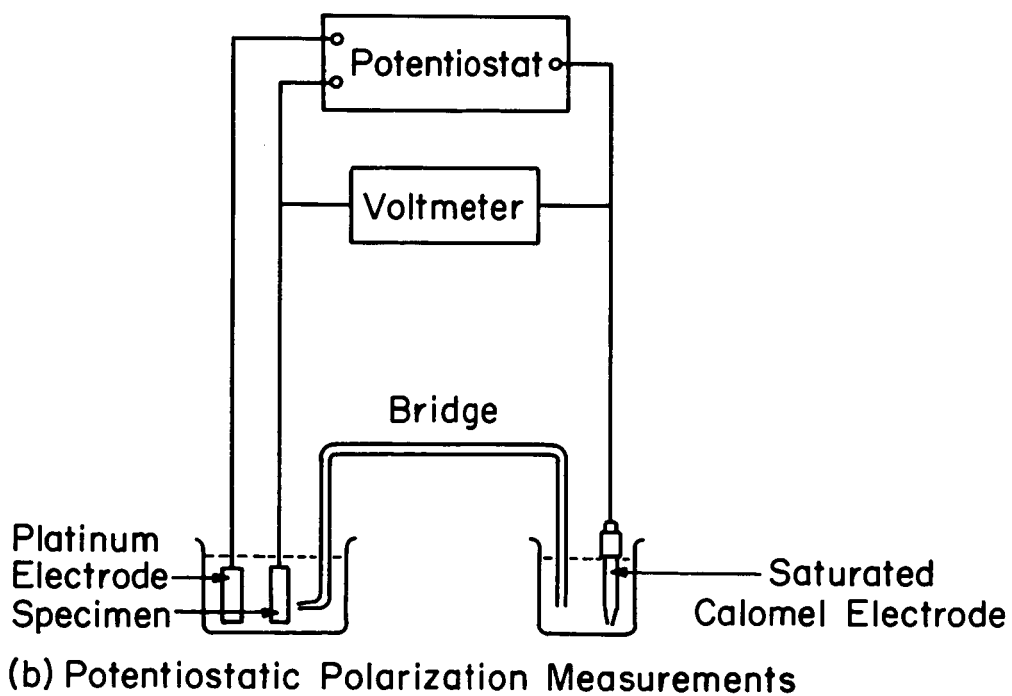
Figure 3. Schematic Circuit Diagrams

the test solution. A compensating device consisting of a micropotentiometer and a standard cell converted the potential values directly to the calomel scale, and these values were measured with a 610B Keithley electrometer. A schematic circuit diagram is shown in Figure 3(a).

The schematic circuit diagram for the potentiostatic measurements is shown in Figure 3(b) and includes an Anotrol Model 4700 potentiostat, a voltmeter, saturated calomel electrode bridge, and working cell. The latter has a volume of 750 ml and inlets for gas injection, reference, auxiliary and working electrodes. The auxiliary electrode is platinum. The foil specimen is mounted on a cylindrical tapered stainless steel holder with a tapered Teflon sheath holding it on and preventing access of the solution to all but a finite area of the specimen surface. The foil specimen so mounted is under an elastic bending stress. The holder arrangement is free from solution leakage, can be rapidly assembled, and provides a solderless electrical contact. The holder is mounted on a Stern-Makrides<sup>5</sup> assembly. The polarization cell is shown in detail in Figure 4.

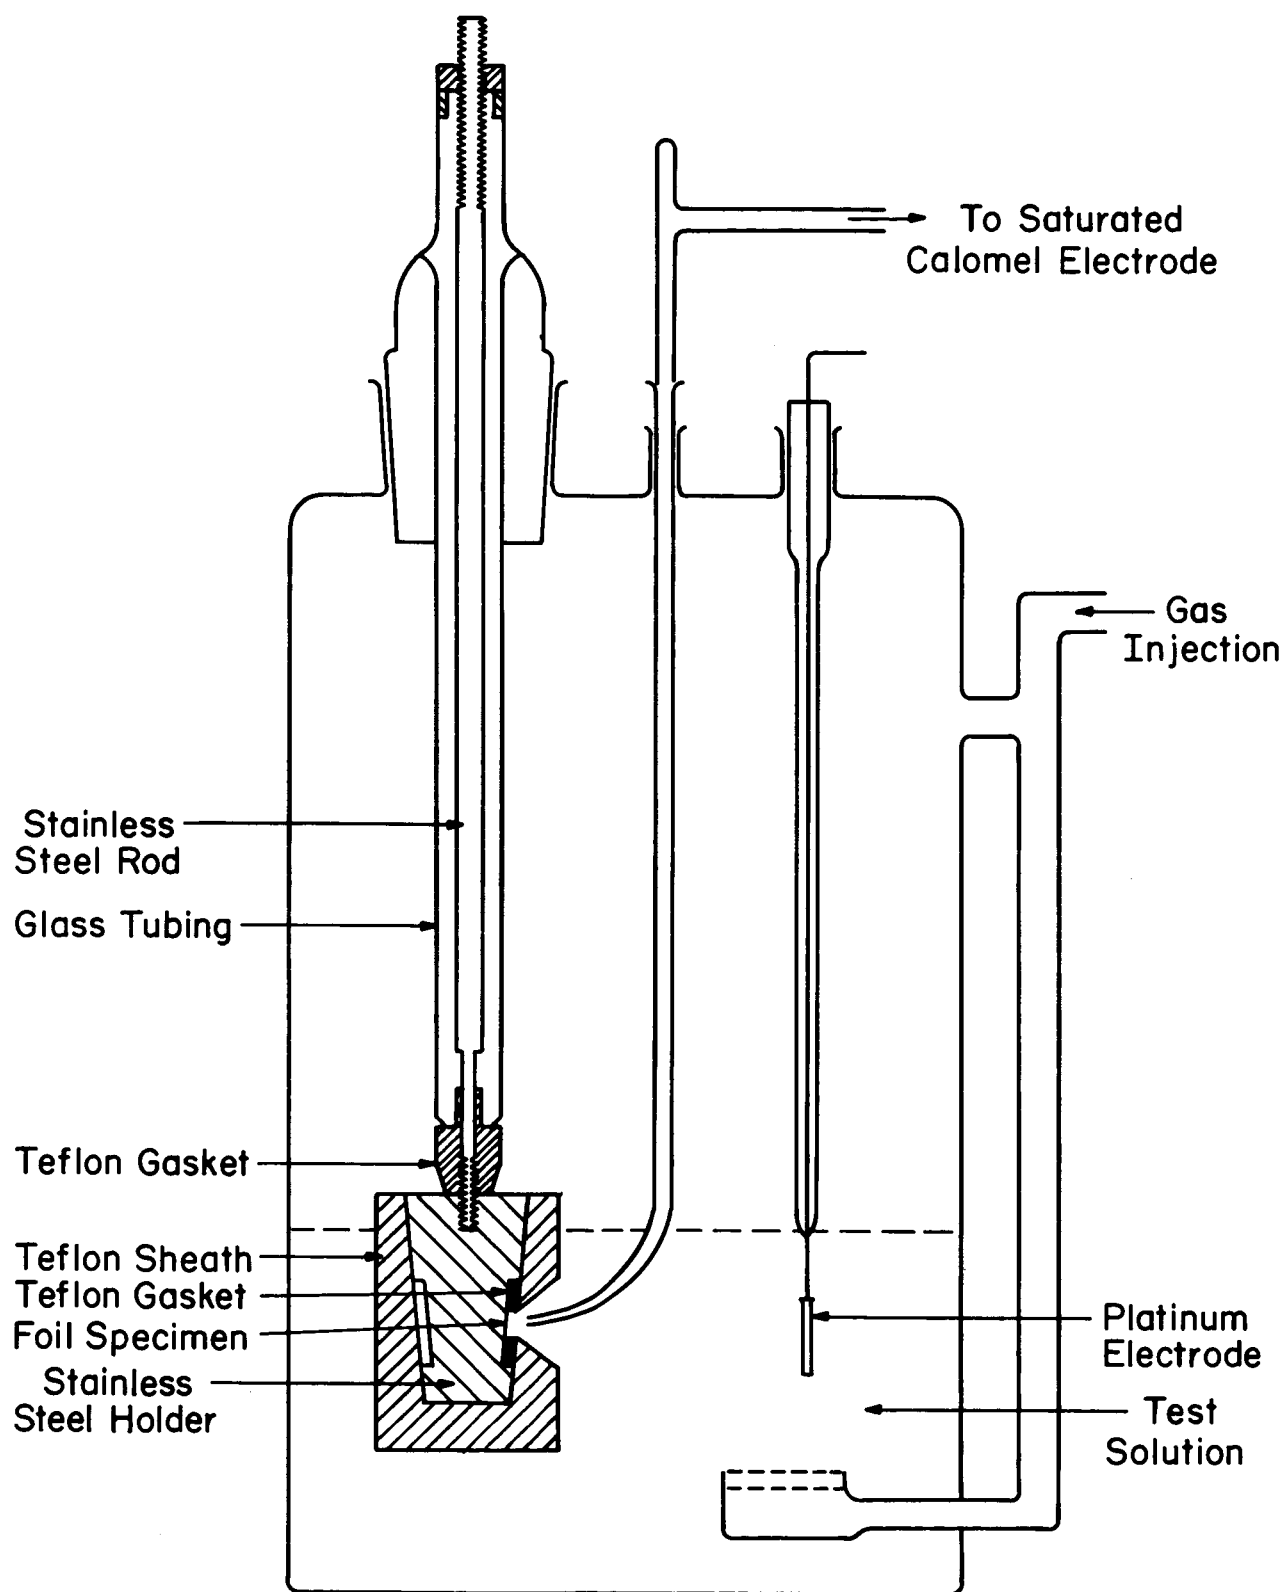
Figure 4. Polarization Cell

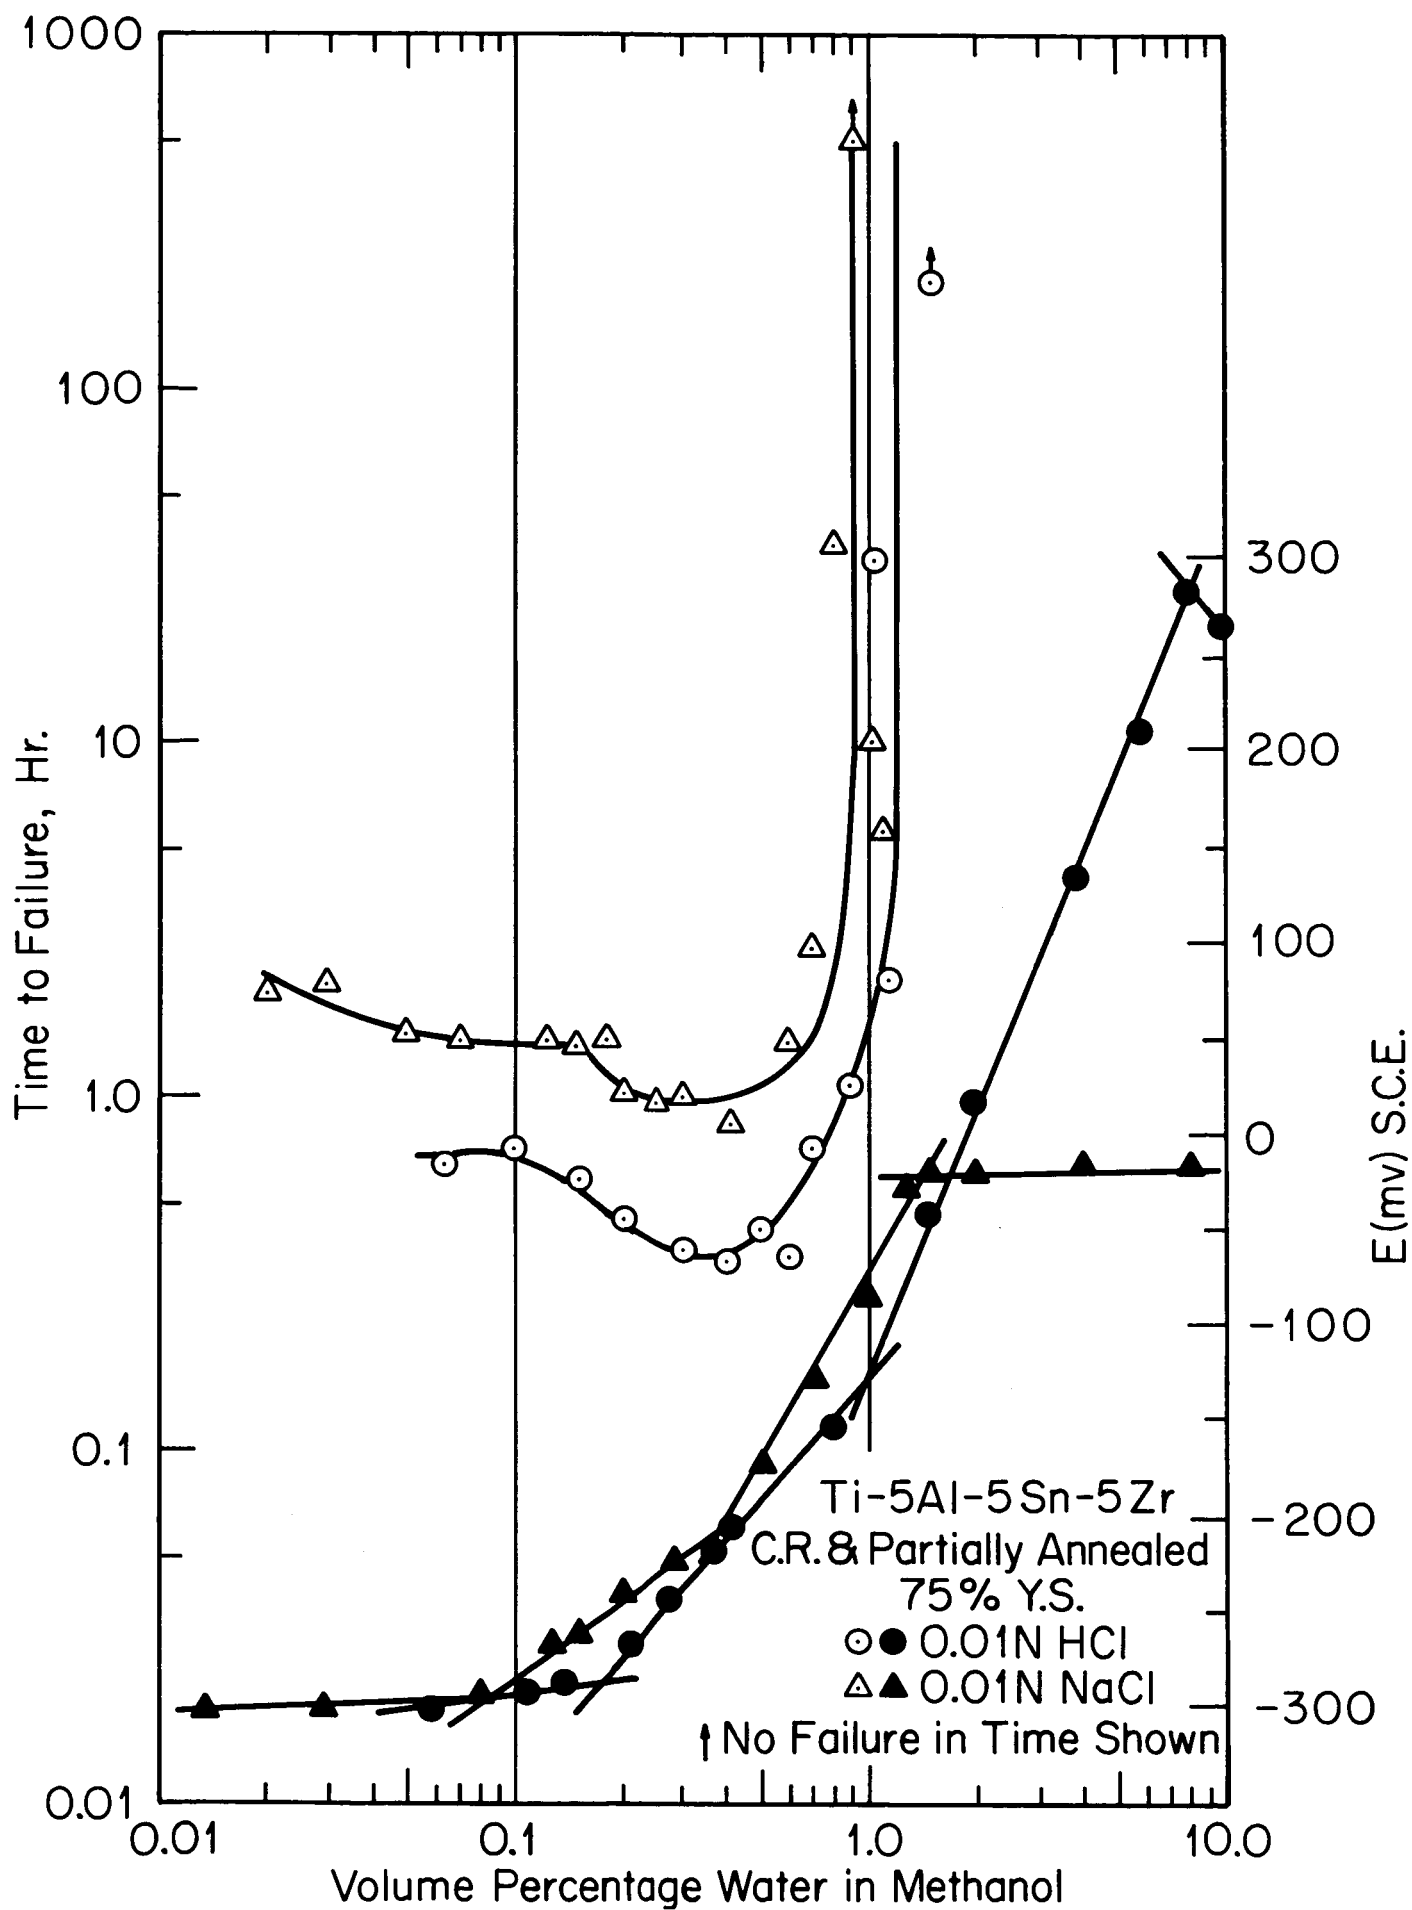
Figure 5 Comparison of time to failure with one-hour electrode potential value.

Effect of Solution Composition - Earlier work in this laboratory has established that methanol solutions containing small additions of HCl or NaCl are capable of cracking the alloy when loaded to 75% Y.S. Figure 5 shows the curves obtained in solutions containing 0.01 N HCl and 0.01 N NaCl, plotting log time to failure versus log volume percentage water in methanol. It can be seen that the times to failure go through a minimum and that a sufficient water content will inhibit the cracking process, at least up to exposure times of 500 hours. The electrode potentials of unstressed specimens, measured 1 hour after immersion, are also shown in Figure 5, from which the inhibition of cracking is apparently associated, at least in part, with the increased nobility of the metal surface.

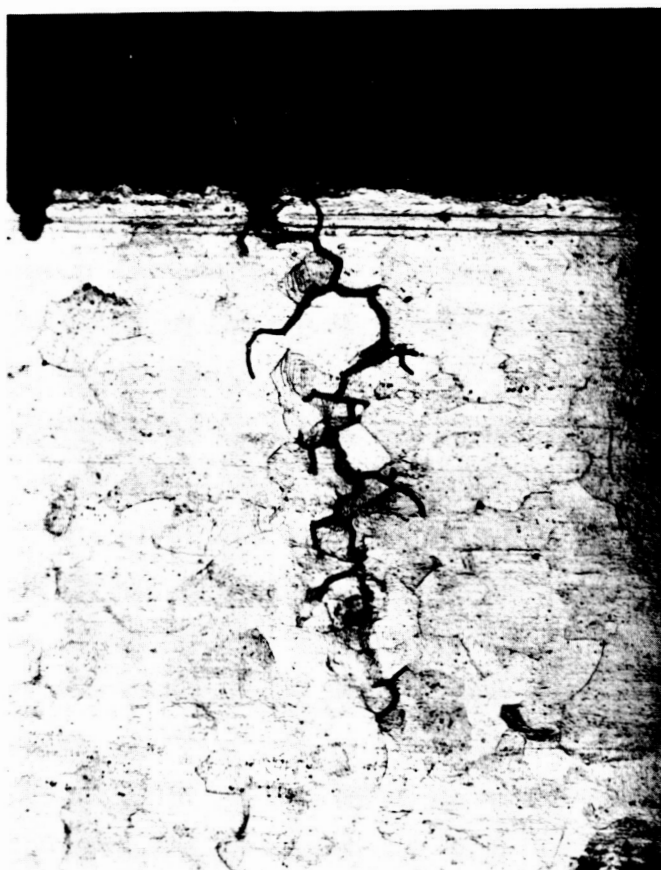
Figure 6 Intergranular crack in Ti-5Al-5Sn-5Zr, tested at  
75% Y.S. in  $\text{CH}_3\text{OH} + 0.01\text{NNaCl} + 0.25\% \text{H}_2\text{O}$ .

Etched 250X

Metallographic examination of failed specimens revealed subsidiary cracking along the exposed section, the density of cracking being greater the lower the water content. However at the higher water contents, the individual cracks were found to be longer. In specimens which did not fail, no cracks were found. In all cases, the cracks were found to be mainly intergranular (Figure 6) with very little or no deformation being visible in the grains immediately adjacent to the fracture edge.

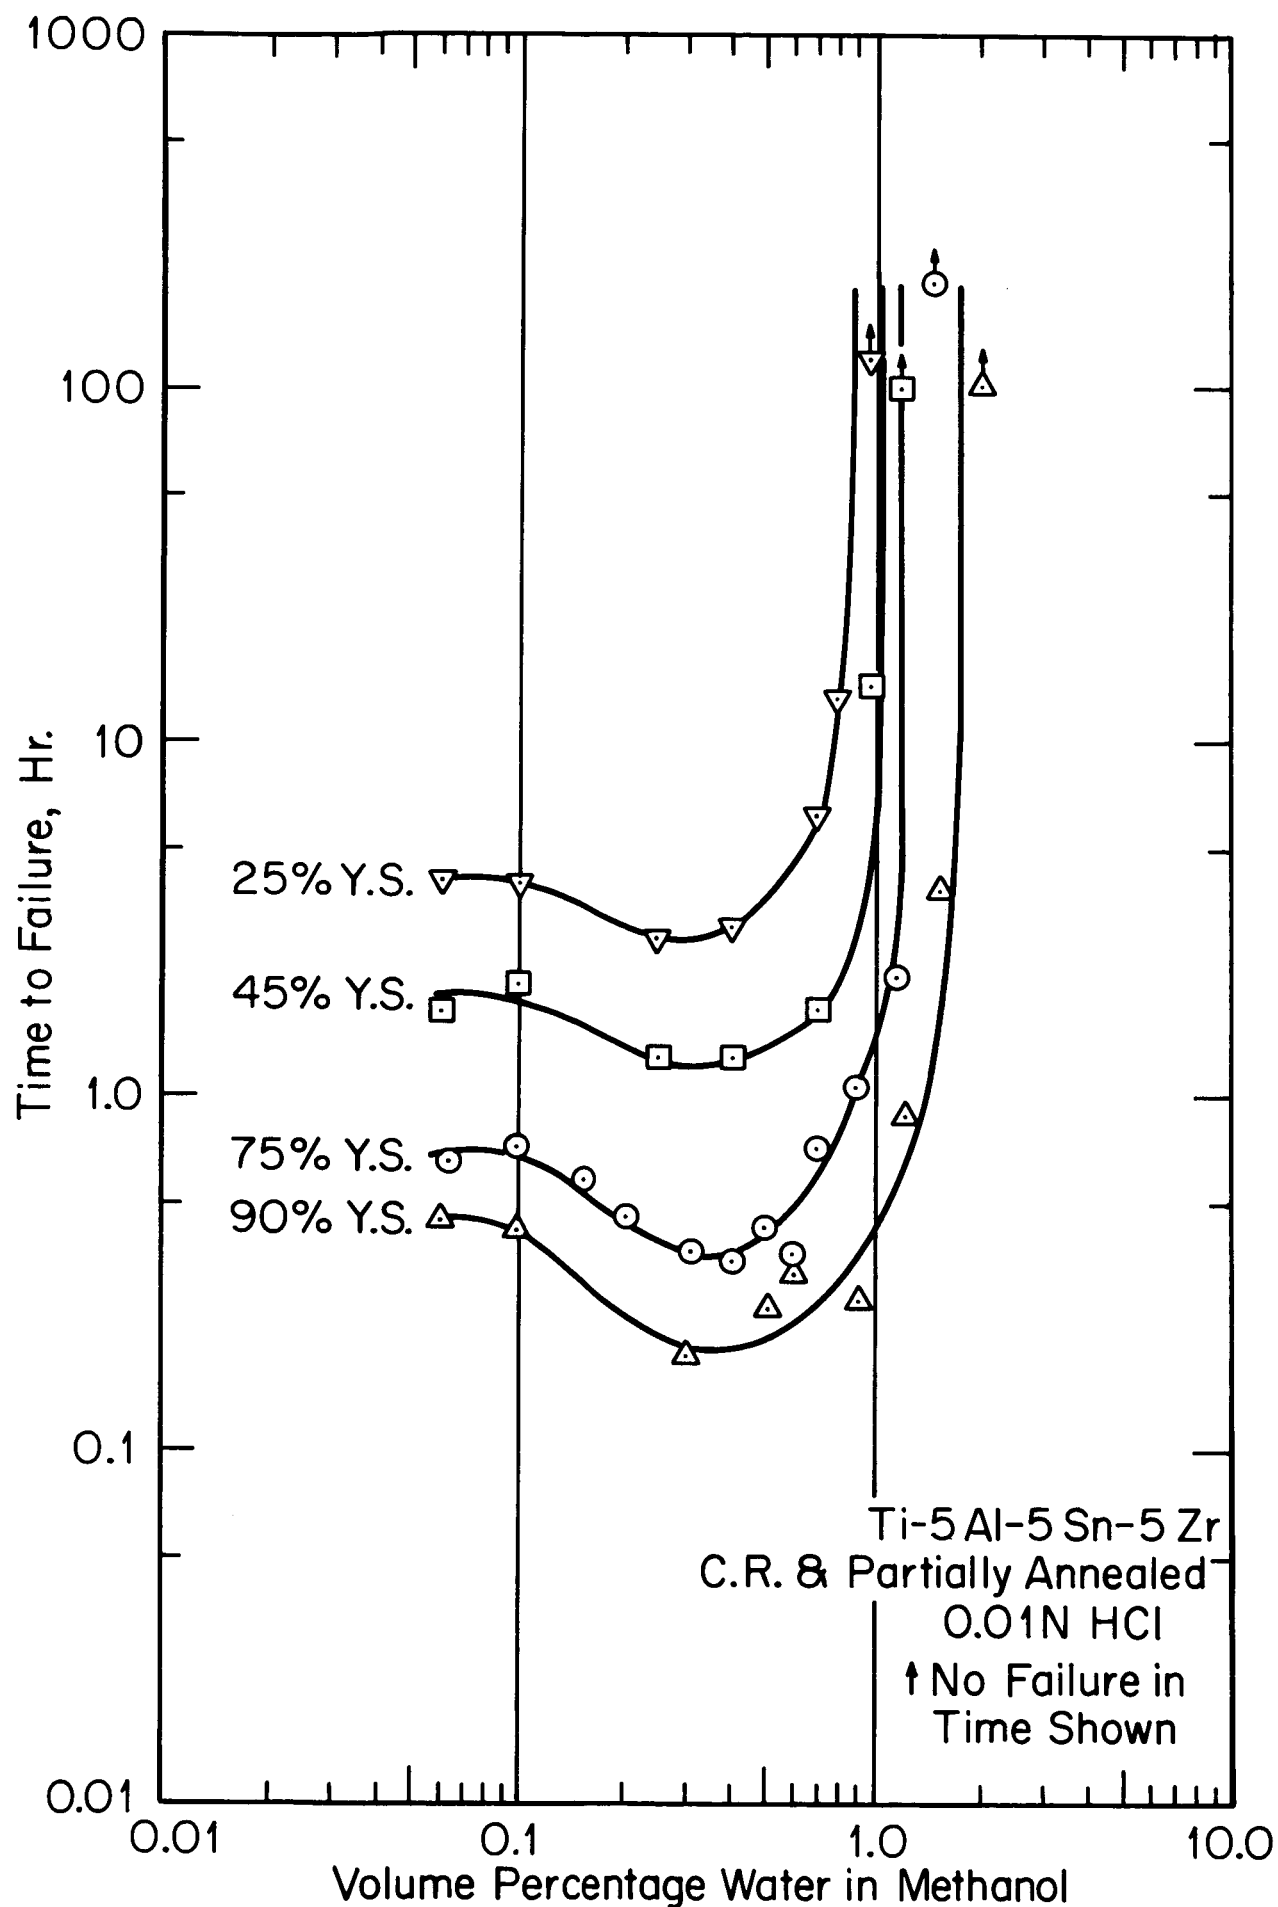
Figure 7 Effect of stress level and solution composition on time to failure.

Effect of Applied Stress - By testing specimens at 25%, 45%, and 90% Y.S., a nest of curves similar to those shown in Figure 5 were plotted and are shown in Figure 7 for the methanol solutions containing HCl. As expected, the times to failure are reduced at the higher stresses as well as the percentage water needed for inhibition being slightly increased. Also, the position of the minimum remains fixed, within experimental accuracy, independently of the stress, again implying the strongly influencing nature of electrochemical phenomena, at least for crack initiation.

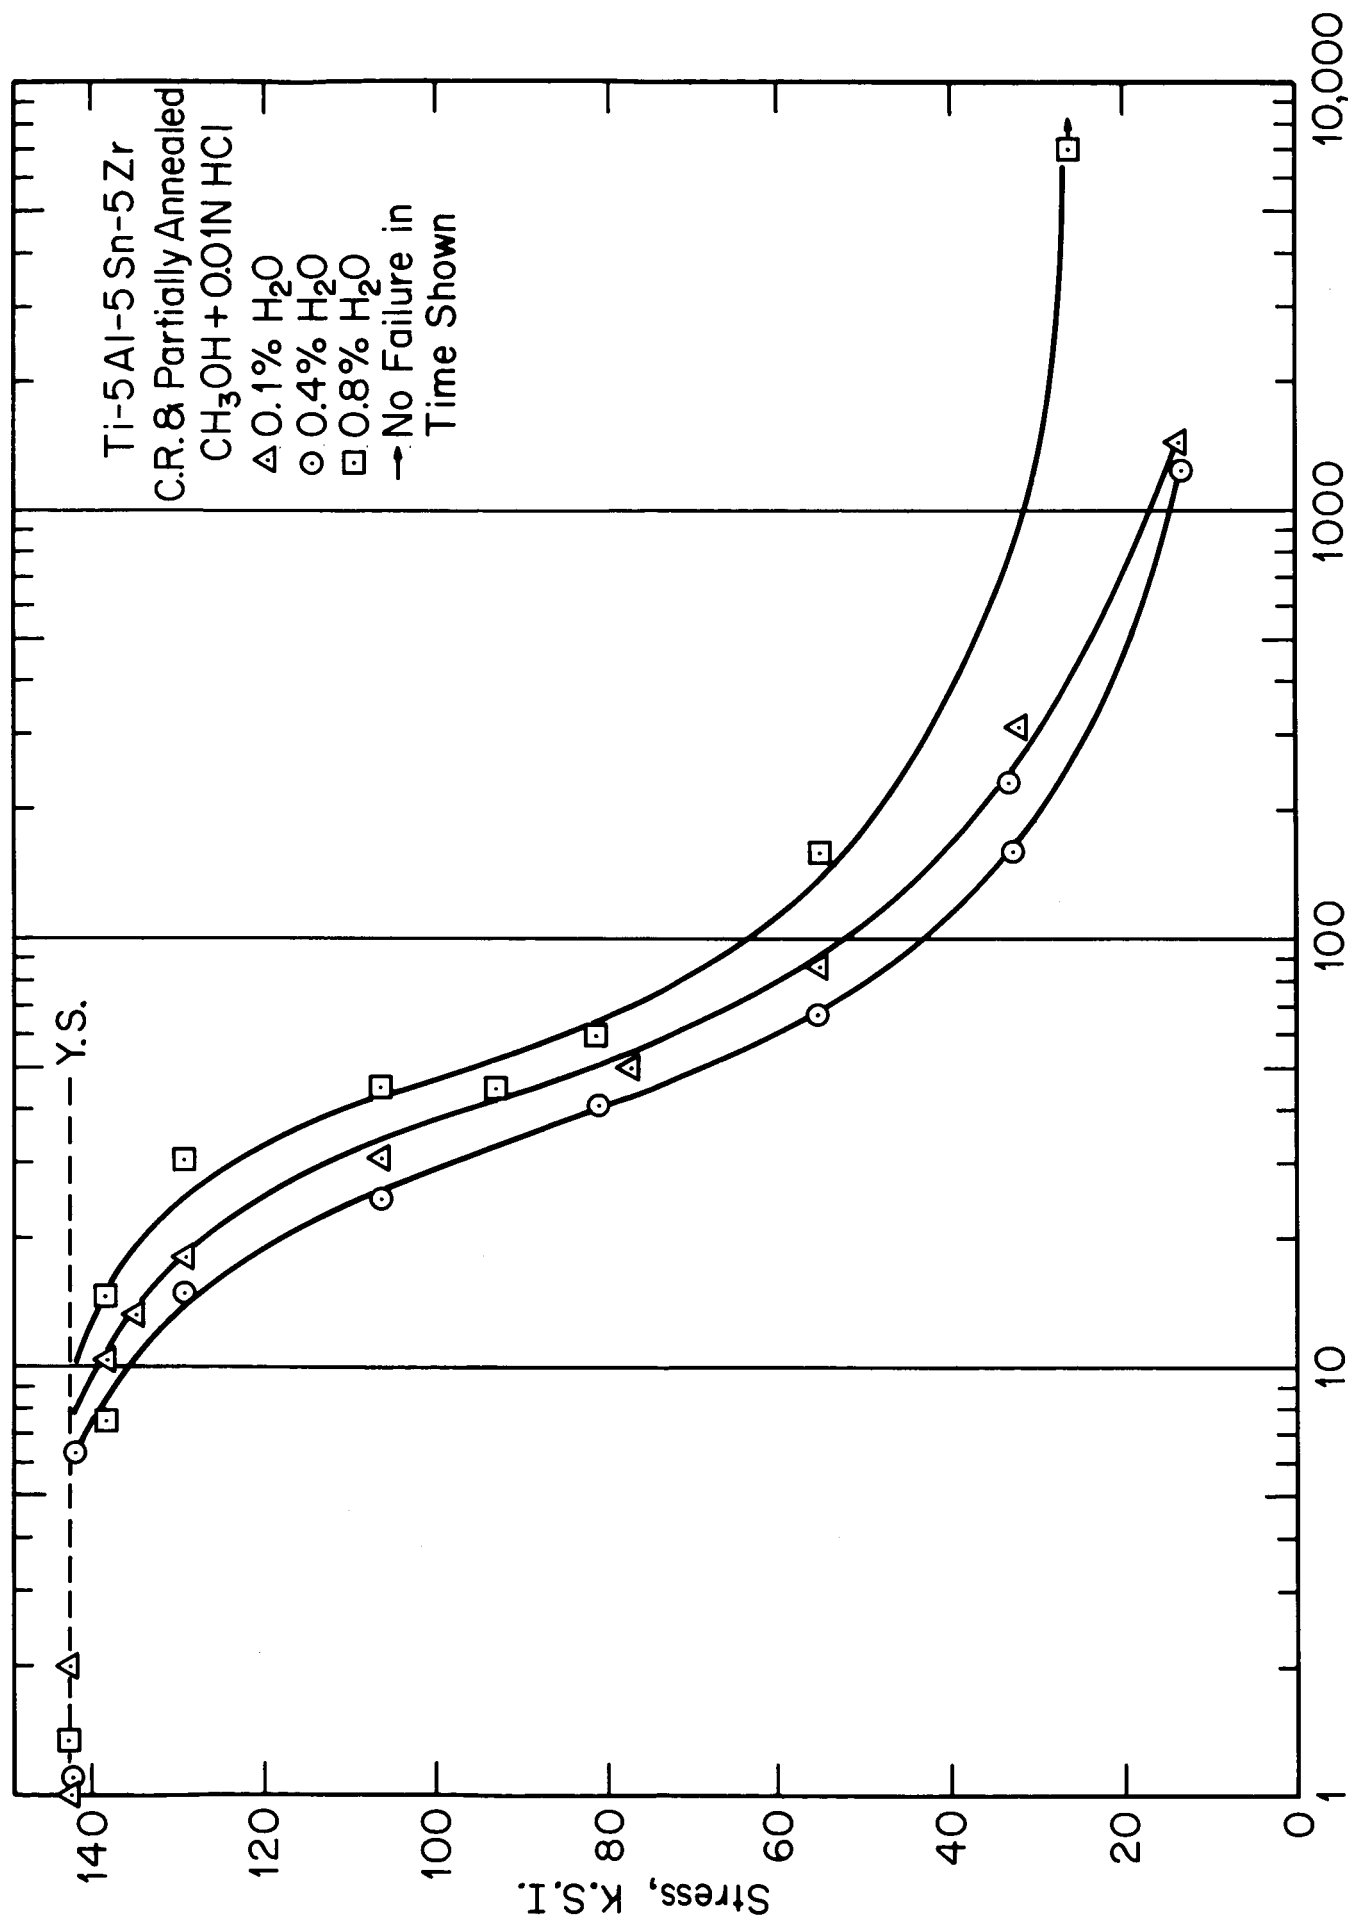
Figure 8 Effect of applied stress on time to failure.

To further investigate the role of stress in the cracking mechanism, curves were plotted of applied stress versus log time to failure for solution compositions corresponding to the minimum and to each side of the minimum, Figure 8. It can be seen that in the region of the yield stress, where marked plastic deformation would be expected to occur, there is a sudden reduction in the time to failure. Also, the solution producing the minimum time to failure at 75% Y.S. (Figure 5) is equally effective at all applied stresses; and failure can occur under stresses as small as 10% Y.S. Therefore, it would appear that although

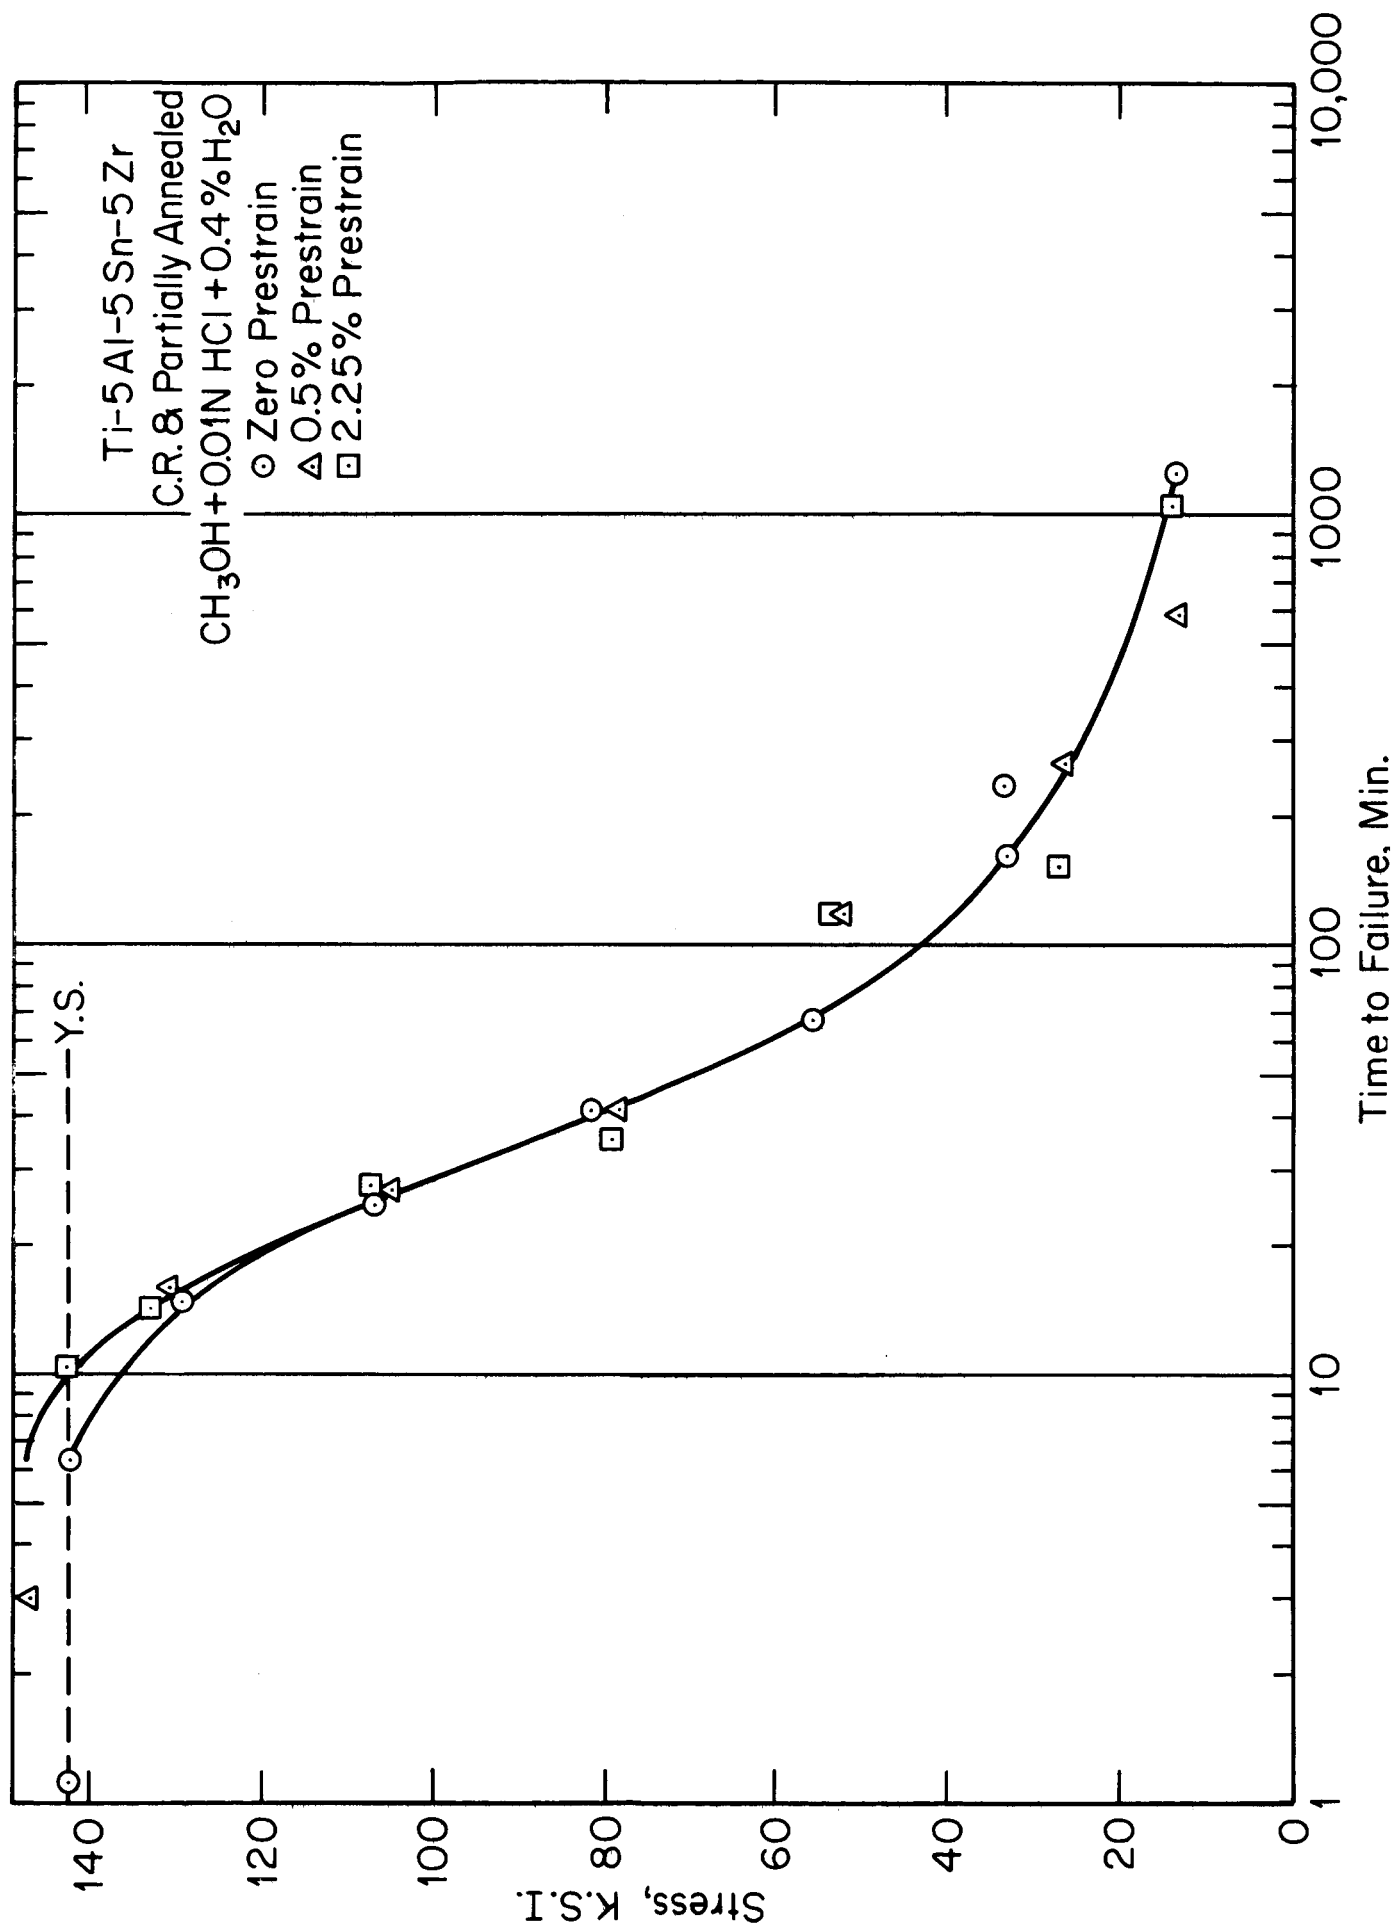
Figure 9 Effect of prestrain on time to failure.

Ti-5Al-5Sn-5Zr  
C.R. & Partially Annealed 75%Y.S.

CH<sub>3</sub>OH + 0.01N NaCl

plastic yielding produces a marked reduction in the failure time, it is not a necessary condition for crack initiation, again suggesting the predominance of some electrochemical reaction. This suggestion is further supported by plotting curves similar to Figure 8 in which, prior to testing, the specimens were pre-plastically strained 0.5% and 2.25% (Figure 9). The shape of the curve is reproduced, independent of the prestrain the specimen received, although the stress at which there is a sudden reduction in the failure time increases slightly with the degree of prestrain.

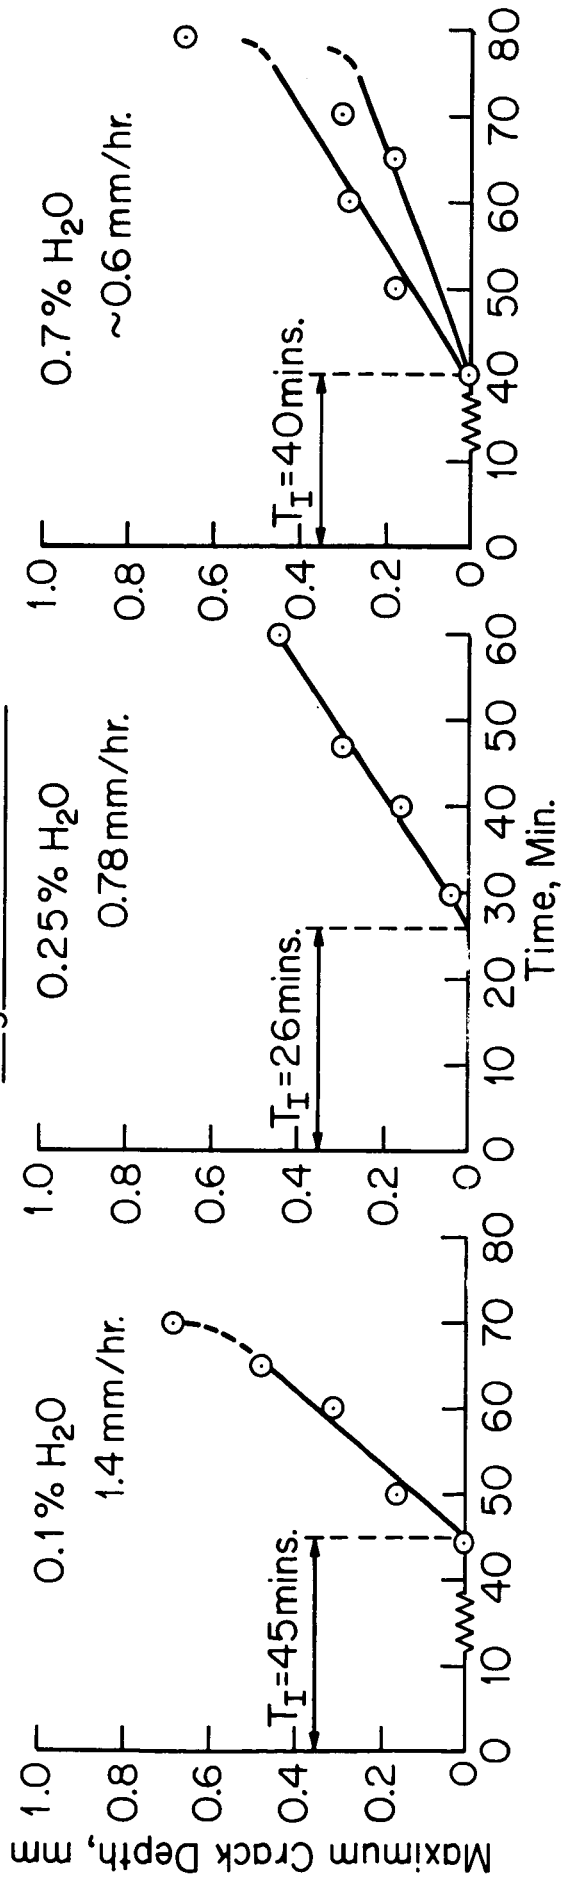
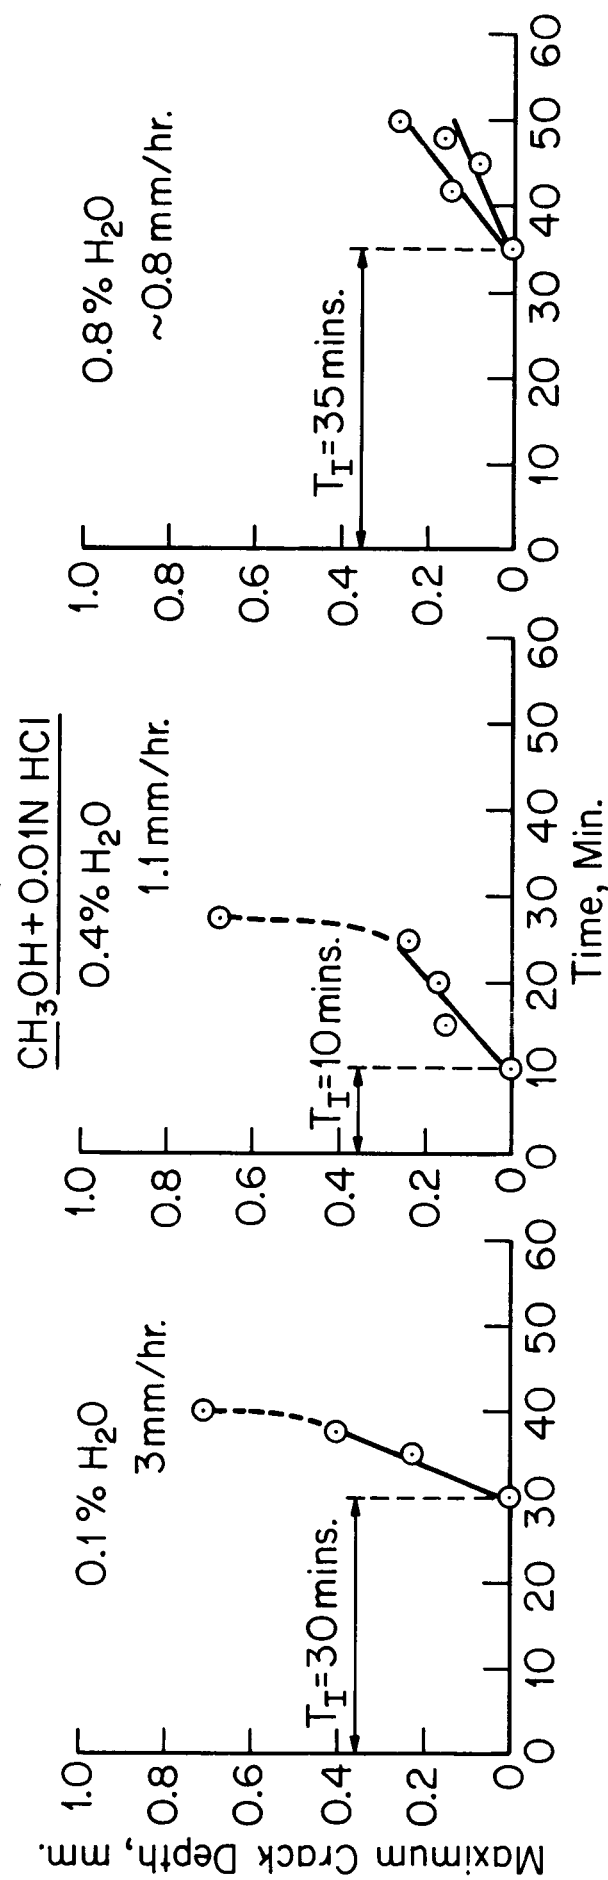
Figure 10 Effect of solution composition on crack propagation rates.

Crack Propagation Rates - Studies of crack propagation rates were made on the alloy in solutions corresponding to the minima and to each side of the minima in Figure 5. The detailed results are shown in Figure 10. As well as illustrating a number of interesting points, they provide a possible explanation for the occurrence of the minima in the times to failure curves with respect to water content. The main difference between the solutions containing NaCl and HCl appears to be due to the enhanced chemical reactivity of the acid solution resulting in shorter incubation times and higher crack propagation rates. The general trend in both solutions appears to be that as the water content is increased, so the crack propagation rate is gradually reduced. It must be pointed out that throughout the work, difficulty was often encountered

in solution compositions on the higher water side of the minimum, resulting in the scatter as shown in the two curves in Figure 10. However, the most important result is that the incubation times are found to go through a minimum and this effect more than off-balances the reduced propagation rate, producing a minimum in the time to failure curve. Although the reason for the occurrence of the minimum in the incubation time is obscure at this time, a possible explanation could be afforded by electrochemical considerations; the environment at the minimum being particularly favorable for crack initiation, lying between regions of general corrosion and passivation. The role of the externally applied stress may then be to concentrate and accelerate attack at the stress concentrations produced at the sites of initial electrochemical action.
